# Bitter Lake Shoreline Assessment Summary Report

**June 2015**

**Submitted to the Bitter Lake Association by Watersheds Canada**

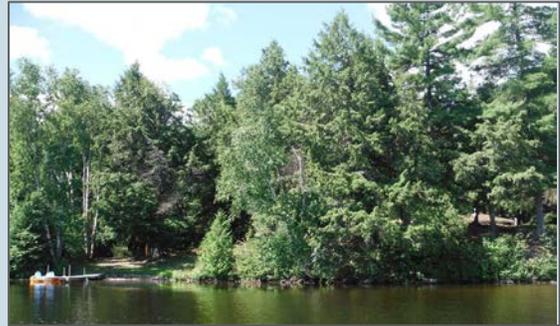
**Natural** – A healthy buffer of vegetation and/or a natural shoreline of sand or exposed rock that is undisturbed and undeveloped.

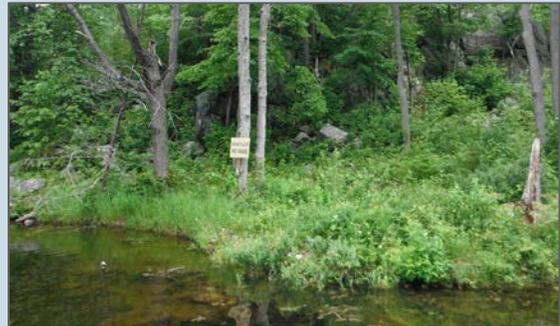
**Regenerative** – Natural vegetation has been removed in the past, but is in the process of growing back towards a natural state.

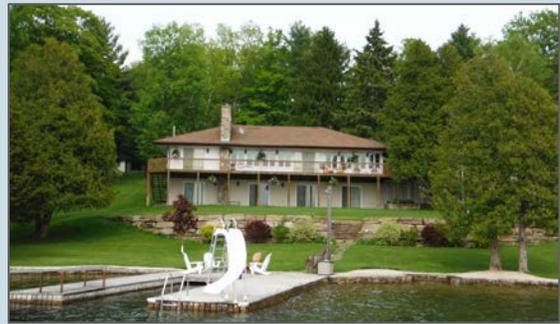
**Ornamental** – All natural vegetation has been removed and replaced with mowed lawn and other non-native vegetation; structures such as docks, decks, boathouses and boat ramps are predominantly present at the shore.

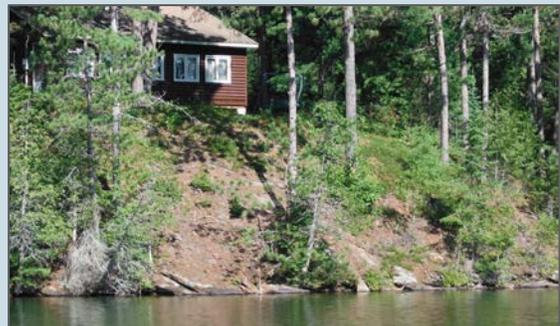
**Degraded** – Natural vegetation has been lost; soil erosion, undercutting of the bank, and/or exposed roots of shrubs and trees are significant.

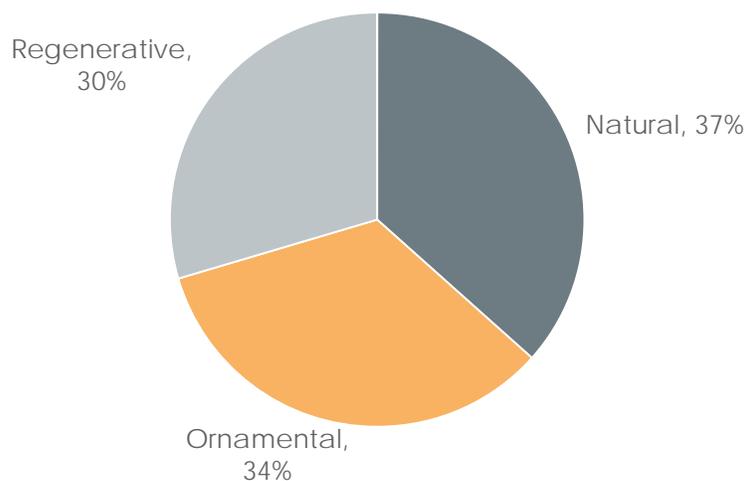
Figure 1 Property Classifications

On Bitter Lake, the relative majority of the shoreline (37%) is classified as natural, followed by 34% being ornamental and 30% being regenerative. It is recommended that shoreline property owners engage in naturalization projects to further decrease the ornamental percentage and increase the regenerative and natural percentages. Bitter lake, is above the recommended limit of 25% developed shoreline.

This presents an opportunity for residents of Bitter Lake to enhance the overall quality of the lake by maintaining, protecting and enhancing natural shorelines. To restore shorelines to more natural states, property owners are encouraged to take action. Regenerative properties should be encouraged to maintain their properties in a natural state.

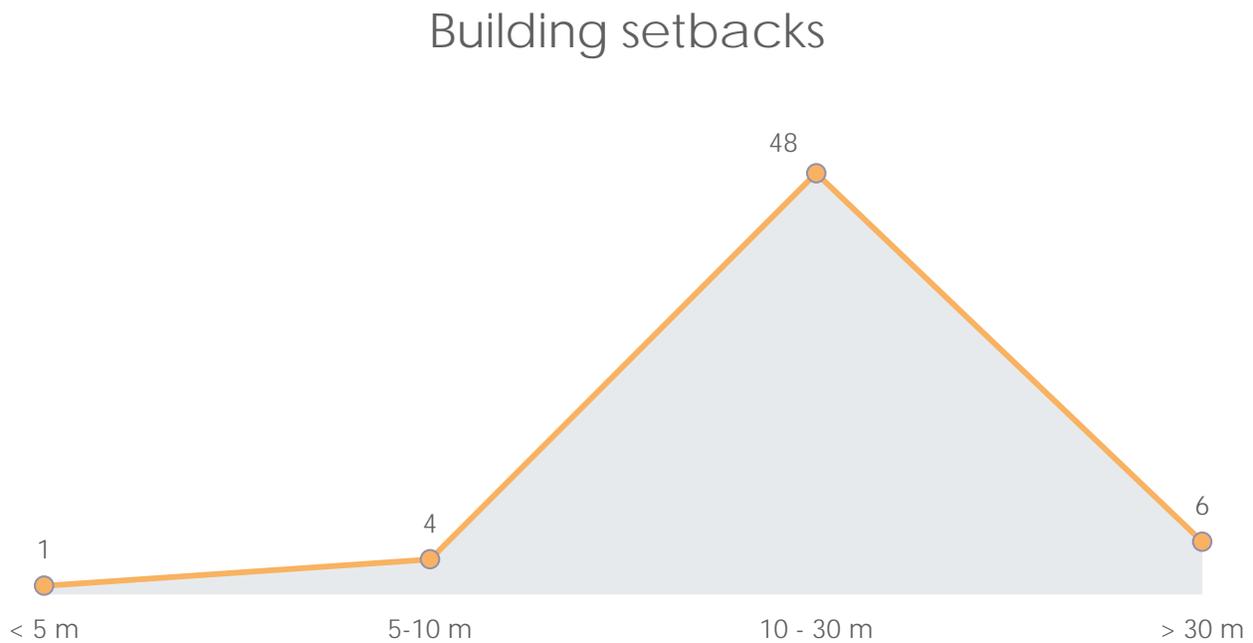
Figure 2 Building Setback Ranges

On Bitter Lake, properties with various building setback ranges were observed and recorded. Shown in figure 2 is the range of building setbacks for properties on the lake. Building setbacks for shoreline developments in Ontario should be at least 30 metres from the high water mark; however, older cottage buildings were permitted closer to the high water mark. On Bitter Lake, 89% of the properties surveyed were observed to be closer than 30 metres to the shoreline. These tend to be cottages or cottages re-developed into homes that were originally built when cottage developments were permitted closer to the water’s edge. The primary problem associated with near-shore building setbacks is the limited area to buffer or filter contaminated runoff and wastewater from the main dwelling. They also disrupt the nearshore habitat corridor that many different animals use to move around the lake environment and into upland areas. While moving these buildings further back from the shoreline may not be a feasible or realistic option, naturalizing the shorelines of these properties would help address this issue.

A potential area of concern with building setbacks is having septic systems installed close to shore. Regular inspections and maintenance of septic systems can help prevent excess nutrients from entering the lake. Nutrients entering the lake can contribute to eutrophication, resulting in increased aquatic vegetation, low oxygen levels and algal blooms. Excess nutrient loading is one of the largest threats to water quality in lakes and rivers; it is everyone’s responsibility to do something to help protect the lake.

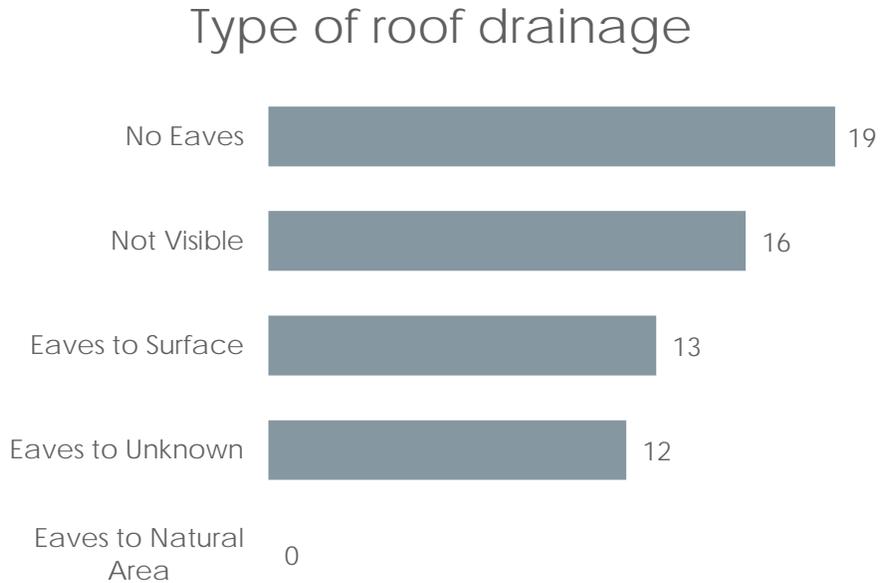
Figure 3 Roof Drainage types around lake

No properties on the lake were identified with having eaves that drain into a rain barrel or with eaves that drain into a natural area. These numbers may be higher, as there were nearly 16 properties where we were unable to identify from the water where the eaves drained to. Because rain barrels are bulky to transport to a cottage area, the lake association may look into ways to make them more available to shoreline property owners. Another option is to install French drains next to cottages to encourage water to percolate into the ground instead of running directly overland into the lake.

Naturalizing shorelines on properties with near-shore building setbacks would help reduce runoff from entering into Bitter Lake, which could help reduce potential problems such as algae blooms and loss of oxygen in the water. Property owners can also manage this problem by ensuring they have eaves troughs with downspouts directed at natural or stone catch basins or rain barrels, as well as ensuring they have a properly functioning septic to process wastewater before it enters the lake. As septic systems do very little to process nutrients, it is also important to use phosphate free products.

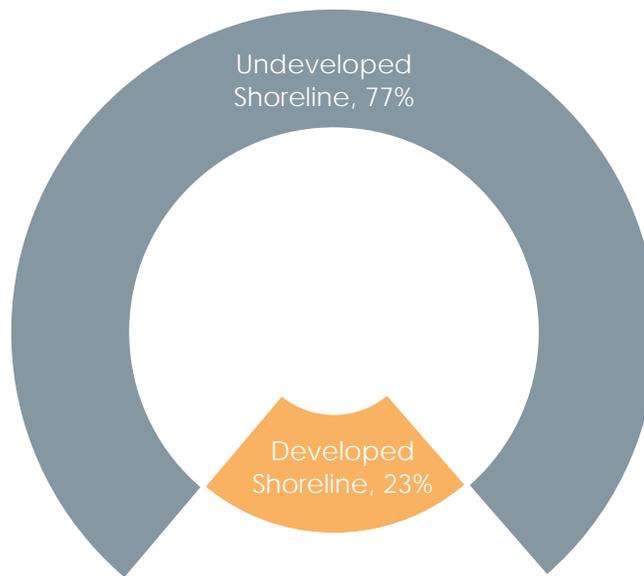
Figure 4 Shoreline Development Percentages

On Bitter Lake, 23% of properties with shoreline development features were observed and recorded within 3 metres of the lake. Shoreline development included the presence of man-made structures on the land or in the water within the first three metres of the shoreline. The diagrams below show the common structures present on the lake as well as the total shoreline development.

Shoreline development structures can, contribute to erosion, and can restrict wildlife access to and from land and water. Although some of these types of structures can have negative environmental impacts because they cover habitat, this can be partially mitigated by allowing vegetation to grow around the decks, boathouses, sheds, stairs, or other man-made structures.

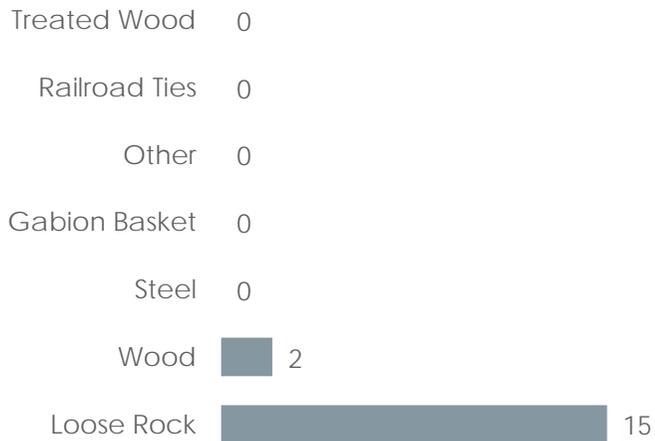
Figure 7 Retaining Walls on Lake

On Bitter Lake, the number of properties with retaining walls was counted and summarized below. Retaining walls, most often built to protect against erosion are a common feature on many lakes. 17 properties on Bitter Lake have retaining walls on their shoreline. The types and frequency of retaining walls is below in figure 7:

17 properties on Bitter Lake, or 23% of properties assessed, have a retaining wall. Of the retaining walls that are present the most common choice was loose rock (15 properties or 21% of properties assessed), followed by wood (2 properties or 3% of properties assessed). While retaining walls were a common choice in the past to combat erosion, we now know about their impact to the natural environment. Waves and wakes are reflected back from flat, hard surfaces with the same force as they strike the wall. This can cause excess turbulence in the water, which scours the sediments from the lake bottom. Solid walls also eliminate shoreline habitat and act as a barrier, preventing wildlife from reaching the water. Although some retaining walls such as rip rap or loose rock have fewer impacts than other retaining walls, shoreline property owners could consider alternative erosion control methods such as planting vegetated buffers or shoreline bioengineering if they ever wish to replace their current, old, or failing retaining wall. In the meantime, maintaining vegetation around the wall and allowing new vegetation to establish and grow will help reduce runoff and provide habitat for wildlife.

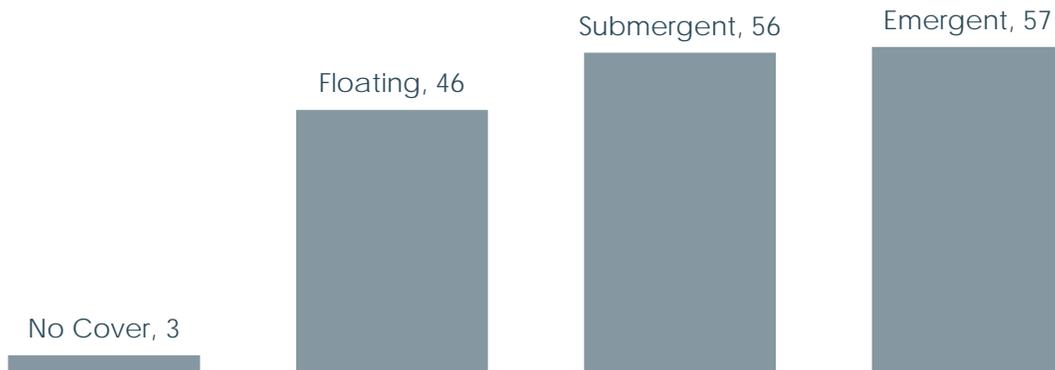
Figure 8 Aquatic Vegetation

On Bitter Lake, the number of properties with aquatic cover were observed and summarized. The presence and abundance of aquatic cover can vary throughout the year. Each assessed property could have one or more types of aquatic cover. Figure number 8 shows the number of properties on Bitter Lake had aquatic cover listed by type observed along their shoreline during the time of the assessments:

4% of properties on Bitter Lake had no aquatic plants while 80% of properties had emergent vegetation which is an important source of habitat for fish, and other aquatic organisms. Floating vegetation was found less frequently on Bitter Lake but is still an important part of the aquatic ecosystem, giving habitat to birds, frogs, dragonflies, and other wildlife. Aquatic cover can create places for wildlife to lay their eggs, provide a perch for predators of fish and insects and offer cover for wildlife. Shoreline property owners that are removing aquatic vegetation from their shoreline properties may be indirectly increasing the presence of invasive aquatic species. Aquatic vegetation may be a problem if there is an overabundance of it due to high nutrient levels entering the lake through runoff. By controlling nutrients entering the lake through well vegetated buffers and other actions shoreline property owners can maintain a healthy balance of aquatic habitat, and space for recreational activities. Bitter Lake appears to be a shallow lake, so the amount of aquatic vegetation is of little surprise.

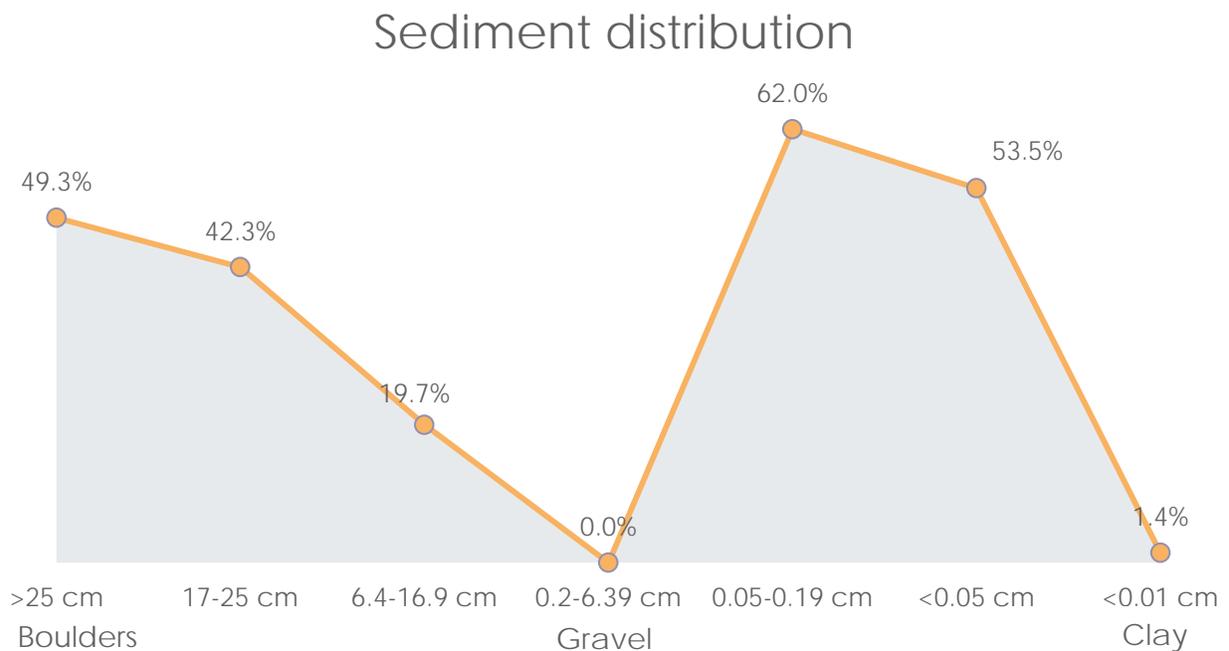
Figure 9 Sediment Distribution

On Bitter Lake, the aquatic substrate types were observed at each property. Figure 9 is the substrate size distribution on Bitter Lake. Aquatic substrate can be important habitat for fish and other aquatic wildlife and it is useful to document this feature to better inform future restoration projects on the lake. Bitter Lake was found to have a good variety of aquatic substrate throughout the lake for supporting aquatic biodiversity. Rubble and cobble provide great habitat for crayfish and spawning grounds for various species of fish while other environments provide excellent substrate for diverse aquatic vegetation.

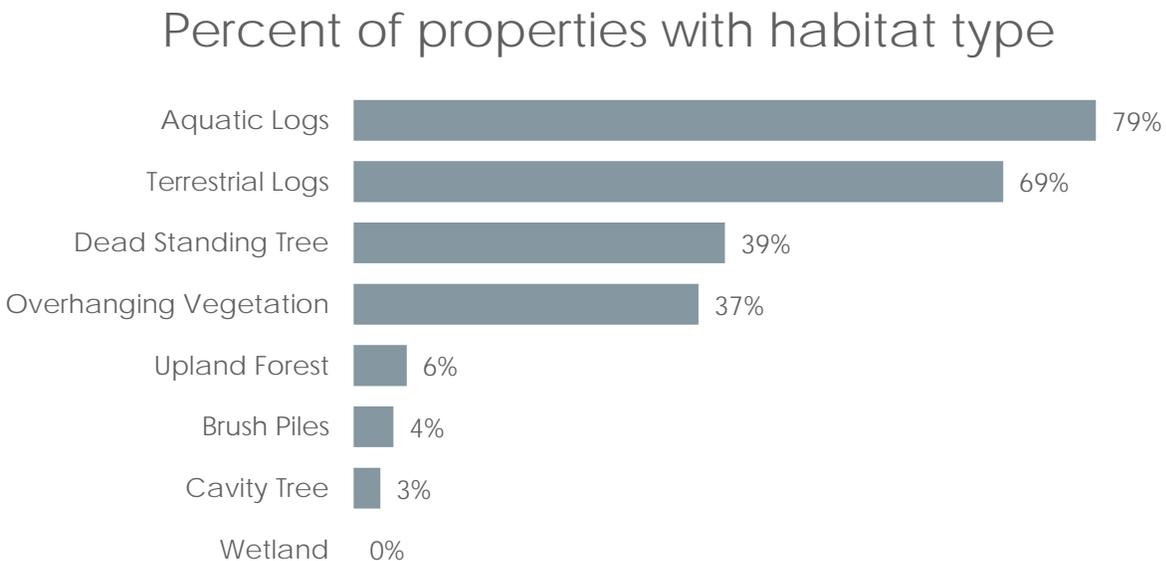
Figure 10 Habitat Present

Most common types of nearshore habitat on Bitter Lake were aquatic logs, followed by terrestrial logs. Most properties on Bitter Lake had some amount of habitat present. Wildlife provides us with many enjoyable and beneficial activities from bird watching and wildlife photography to pest control, seed dispersal, nutrient cycling and pollination, to name just a few. It is important for there to be a rich and diverse range of habitats along the lakeshore to ensure a healthy lake environment. Figure 10 summarizes the lake nearshore habitat.

It is important to leave large trees that are dead and dying in place, as they provide important habitat for a number of different species. In Ontario, more than 50 species of birds and mammals depend on cavity trees for nesting, rearing young, roosting, feeding, storing food, escaping predators, and hibernating. Fallen logs on land provide habitat for small mammals such as moles, woodpeckers, toads and insects. As the log decomposes, reptiles and amphibians lay their eggs in the moist wood. A decaying log is also great habitat for beetles, and ants that burrow under the bark and lay eggs. In the water, logs provide important fish habitat by providing

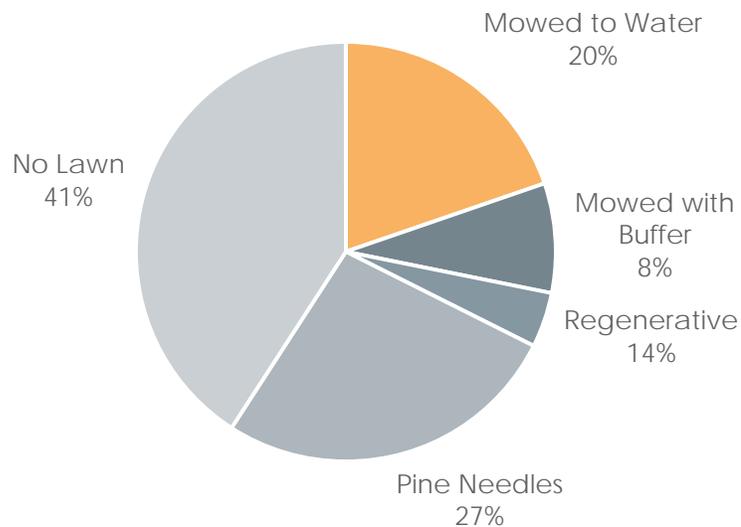
Figure 11 Lawn types

On Bitter Lake, the number of properties with lawns, either mowed or regenerative, was observed. 35% of properties with lawns were observed to have a mowed lawn to the water’s edge. Natural ground cover and native vegetation, in comparison, slows runoff and allows filtration, removing many contaminants, pollutants, nutrients, sediment and other substances. These substances can be carried into the lake by runoff and can harm water quality and local ecological integrity. Lawn grasses also have short root systems and do not bind the soil well, which can lead to problems with erosion.

In areas close to shore, a lawn is generally not a good choice of ground cover as 55% of precipitation runs off mowed grass directly into the lake, instead of returning to groundwater. If shoreline property owners wish to mitigate this, they could consider allowing vegetation to regenerate on its own or by actively planting native trees, shrubs, grasses, or alternative ground cover. The roots of the vegetation will grip the soil, which can help prevent erosion. Allowing mowed lawns to regenerate to a more natural state promotes water conservation and protects surface and groundwater resources. Properties with regenerative lawns are encouraged to allow this natural process to continue and to enhance regeneration by planting native shrubs and trees.

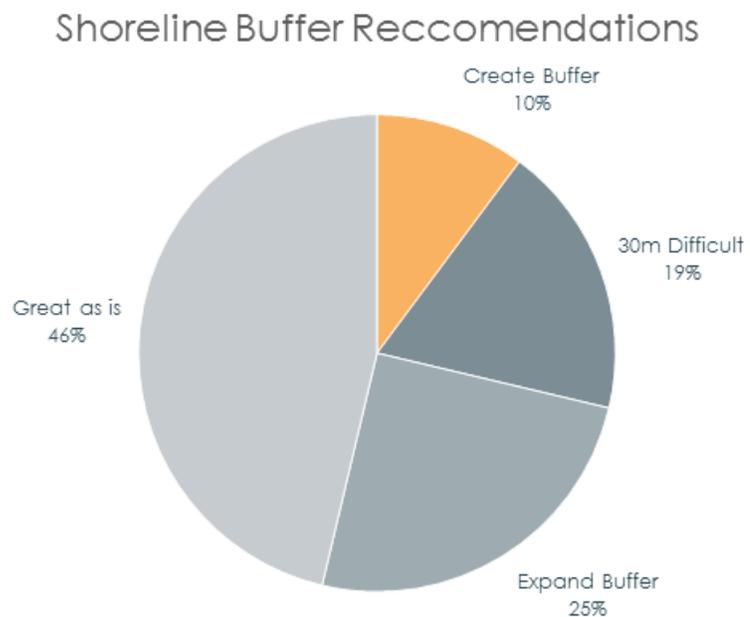
Figure 12 Buffer Recommendations

Arguably the most important element of a shoreline that property owners can easily influence is shoreline buffers. Buffers are an important element of natural shorelines that help filter nutrients, reduce erosion, and provide habitat. On Bitter Lake, 10% of properties have enough room between the main residence and the lake for the creation of a shoreline buffer to provide benefits to water quality and habitat. 46% of properties were noted to have great buffers as they are. In order to ensure the sustainability of a healthy lake environment it is important that natural buffers make up at least 75% of the lake shoreline, preferably as much as 80%.

There are a number of options shoreline property owners have to improve or increase the size of their buffer. Watersheds Canada and the Canadian Wildlife Federation is offering shoreline naturalizations funded through the Department of Fisheries and Oceans Canada. The data collected previous in this report was used to calculate shoreline naturalization priorities. The categories are as follows:

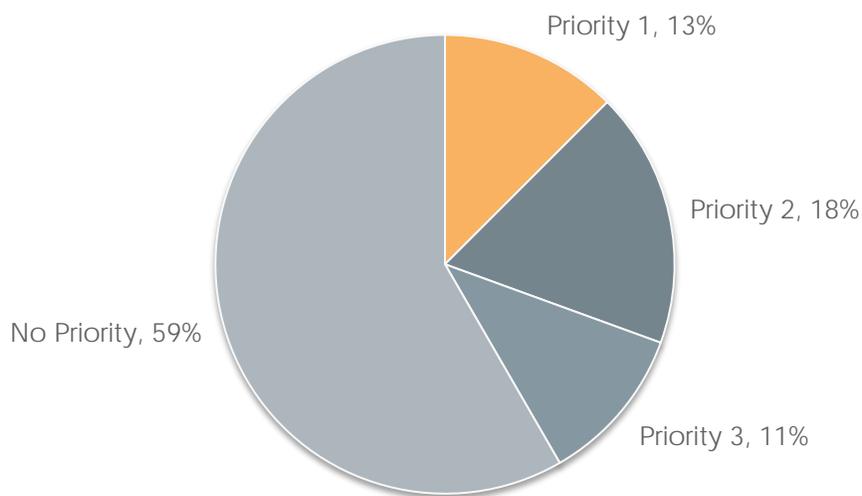
Figure 13 Naturalization Priorities

- Priority 1: The best candidates for naturalization efforts. These properties have more than 50% of their shoreline classified as ornamental. Additionally these properties have at least 30 metres of space between the water's edge and their main building (house/cottage). These properties are recommended to either create a buffer or expand their current buffer.
  - These shoreline property owners are encouraged to naturalize their shorelines, because their efforts would have the greatest overall impact on the health of their shoreline and the lake. They have an opportunity to plant a healthy buffer of native vegetation that could be 30 metres wide. When designing a planting plan, they can maintain room for access to the water (via raised staircases or covered, curved pathways). Lower growing vegetation can be chosen to

- Priority 2: The second best candidates for naturalization efforts. These properties have more than 25% of their shoreline classified as ornamental. However, some of these properties have less than 30 metres of space between the water's edge and their main building (house/cottage), which could make planting more difficult or less substantial. These properties are also recommended to either create a buffer or expand their current buffer.

- Priority 3: These are the third best candidates for naturalization efforts. These properties are already mostly natural or regenerative, and less than 25% ornamental. However, some of these properties have less than 30 metres of space between the water's edge and their main building (house/cottage), which could make planting more difficult or less substantial.

There is some potential for shoreline naturalization on Bitter Lake as greater than 13% of the properties on the lake could potentially be a candidate for naturalization based on our assessment for shoreline naturalization projects. Buffer zones are the ribbon of life, providing over 90% of aquatic and terrestrial wildlife with essential
