Burdock Lake Shoreline Assessment Summary Report

June 2015

Submitted to the Burdock Lake Association by Watersheds Canada

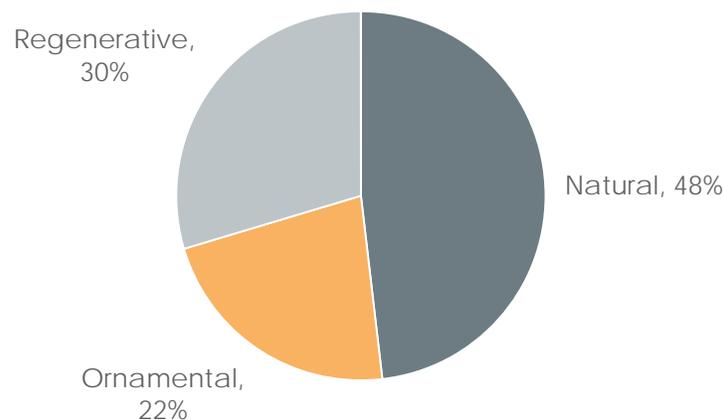
Figure 1 Property Classifications

On Burdock Lake, the majority of the shoreline (48%) is classified as natural, followed by 22% being ornamental and 30% being regenerative. It is recommended that shoreline property owners engage in naturalization projects to further decrease the ornamental percentage and increase the regenerative and natural percentages. Burdock Lake is below the recommended limit of 25% developed shoreline.

This presents an opportunity for residents of Burdock Lake to enhance the overall quality of the lake by maintaining, protecting and enhancing natural shorelines. To restore shorelines to more natural states, property owners are encouraged to take action. Regenerative properties should be encouraged to maintain their properties in a natural state.

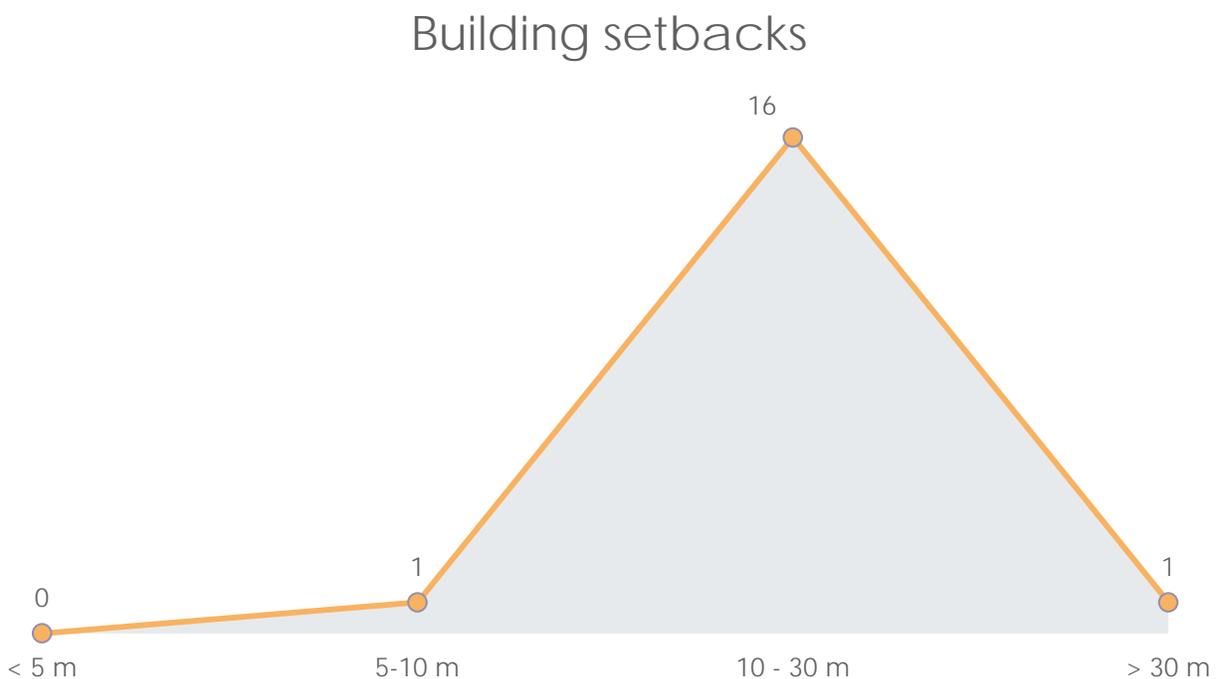
Figure 2 Building Setback Ranges

On Burdock Lake, properties with various building setback ranges were observed and recorded. Shown in figure 2 is the range of building setbacks for properties on the lake. Building setbacks for shoreline developments in Ontario should be at least 30 metres from the high water mark; however, older cottage buildings were permitted closer to the high water mark. On Burdock Lake, 94% of the properties surveyed were observed to be closer than 30 metres to the shoreline. These tend to be cottages or cottages re-developed into homes that were originally built when cottage developments were permitted closer to the water's edge. The primary problem associated with near-shore building setbacks is the limited area to buffer or filter contaminated runoff and wastewater from the main dwelling. They also disrupt the nearshore habitat corridor that many different animals use to move around the lake environment and into upland areas. While moving these buildings further back from the shoreline may not be a feasible or realistic option, naturalizing the shorelines of these properties would help address this issue.

A potential area of concern with building setbacks is having septic systems installed close to shore. Regular inspections and maintenance of septic systems can help prevent excess nutrients from entering the lake. Nutrients entering the lake can contribute to eutrophication, resulting in increased aquatic vegetation, low oxygen levels and algal blooms. Excess nutrient loading is one of the largest threats to water quality in lakes and rivers; it is everyone’s responsibility to do something to help protect the lake.

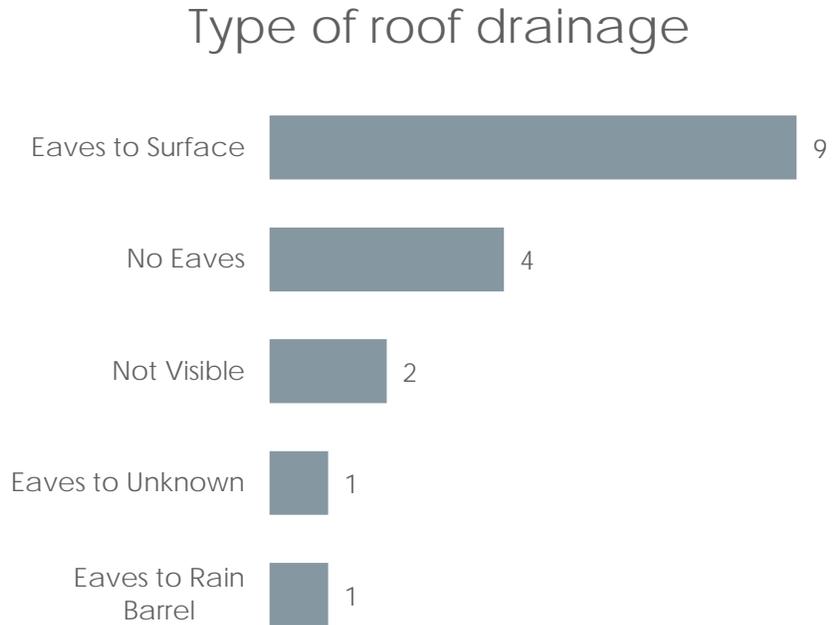
Figure 3 Roof Drainage types around lake

One property on the lake was identified with having eaves that drain into a rain barrel or with eaves that drain into a natural area. These numbers may be higher, as there were 2 properties where we were unable to identify from the water where the eaves drained to. Because rain barrels are bulky to transport to a cottage area, the lake association may look into ways to make them more available to shoreline property owners. Another option is to install French drains next to cottages to encourage water to percolate into the ground instead of running directly overland into the lake.

Naturalizing shorelines on properties with near-shore building setbacks would help reduce runoff from entering into Burdock Lake, which could help reduce potential problems such as algae blooms and loss of oxygen in the water. Property owners can also manage this problem by ensuring they have eaves troughs with downspouts directed at natural or stone catch basins or rain barrels, as well as ensuring they have a properly functioning septic to process wastewater before it enters the lake. As septic systems do very little to process nutrients, it is also important to use phosphate free products.

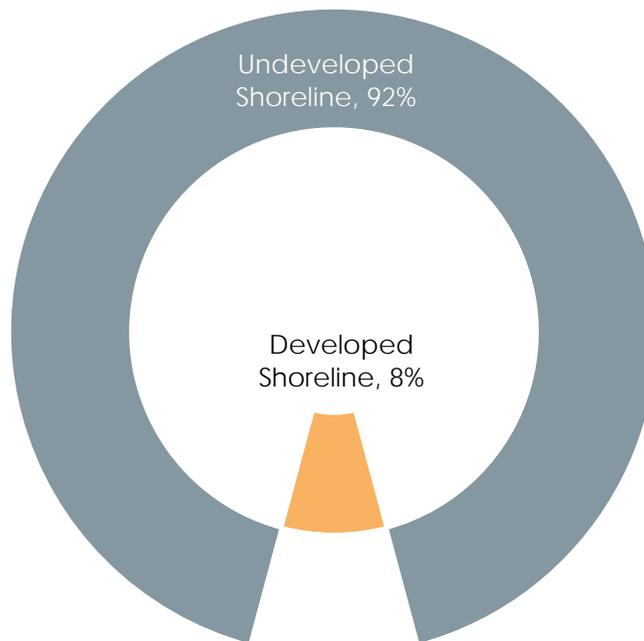
Figure 4 Shoreline Development Percentages

On Burdock Lake, 8% of properties with shoreline development features were observed and recorded within 3 metres of the lake. Shoreline development included the presence of man-made structures on the land or in the water within the first three metres of the shoreline. The diagrams below show the common structures present on the lake, as well as the total shoreline development.

It is recommended for the health of a lake to aim for a no more than 25% of the shoreline developed for access to the lake and recreational space leaving the rest natural. Beyond 25% development, critical functions of the lake that maintain its ecological integrity can begin to fail (Environment Canada, How Much Habitat is Enough? 2013) Therefore, 75% of the shoreline should be left in a natural state in order to provide maximum benefit to the health of the lake. Figure 1 shows the percentage of the entire assessed shoreline in each classification.

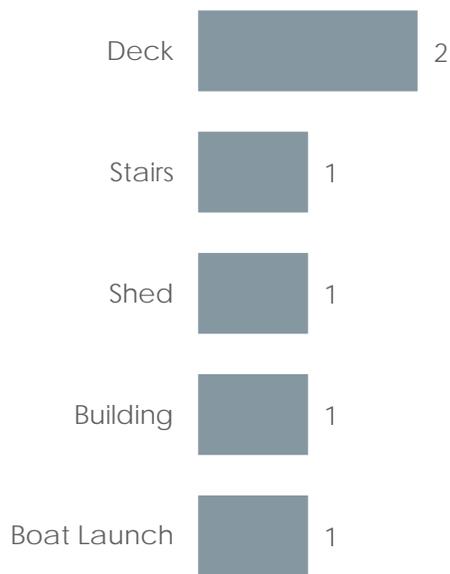
Figure 5 Structures On Lake

Shoreline development structures can, contribute to erosion, and can restrict wildlife access to and from land and water. Although some of these types of structures can have negative environmental impacts because they cover habitat, this can be partially mitigated by allowing vegetation to grow around the decks, boathouses, sheds, stairs, or other man-made structures.

Development along a shoreline can be done sustainably and in an environmentally sensitive fashion, as long as the structures are maintained and kept to a minimal footprint on the waterfront. Burdock Lake below the maximum recommendation of 25% development.

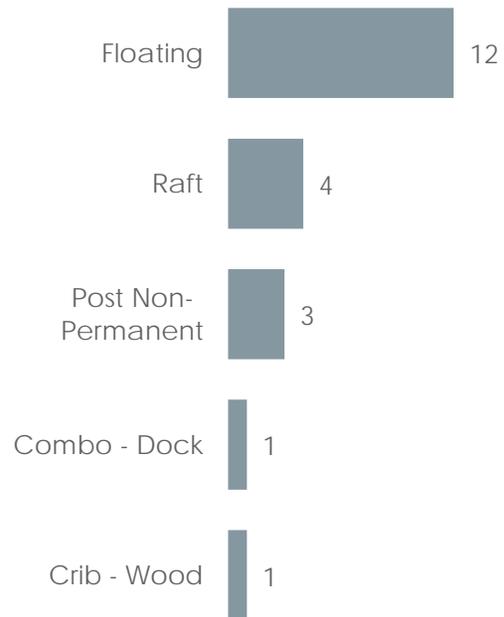
Figure 6 Docks on Lake

Small floating or post non-permanent docks are the best choice of docks as they have minimal contact with the lake bottom, and sit on or out of the water, which reduces the impact they have on the surrounding environment. In the future, if shoreline property owners need to replace their old or failing permanent post,

solid, or crib docks, they could consider a non-permanent post dock or floating dock, thereby limiting impacts to fish habitat and ensuring the natural flow of water remains unrestricted.

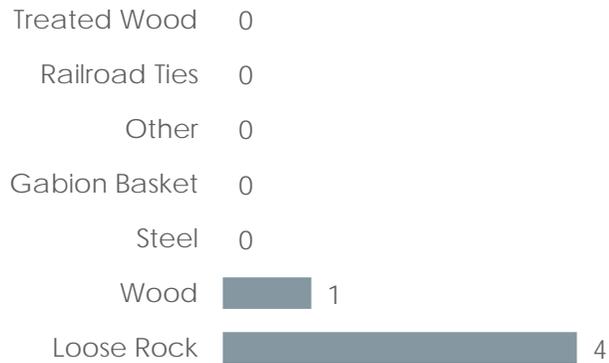
Figure 7 Retaining Walls on Lake

On Burdock Lake, the number of properties with retaining walls was counted and summarized below. Retaining walls, most often built to protect against erosion are a common feature on many lakes. The number of properties with retaining walls was 18% of the total. The types and frequency of retaining walls is below in figure 7:

5 properties on Burdock Lake, or 18% of properties assessed, have a retaining wall. Of the retaining walls that are present the most common choice was loose rock (4 properties or 14% of properties assessed), followed by wood (1 property or 4% of properties assessed). While retaining walls were a common choice in the past to combat erosion, we now know about their impact to the natural environment. Waves and wakes are reflected back from flat, hard surfaces with the same force as they strike the wall. This can cause excess turbulence in the water, which scours the sediments from the lake bottom. Solid walls also eliminate shoreline habitat and act as a barrier, preventing wildlife from reaching the water. Although some retaining walls such as rip rap or loose rock have fewer impacts than other retaining walls, shoreline property owners could consider alternative erosion control methods such as planting vegetated buffers or shoreline bioengineering if they ever wish to replace their current, old, or failing retaining wall. In the meantime, maintaining vegetation around the wall and allowing new vegetation to establish and grow will help reduce runoff and provide habitat for wildlife.

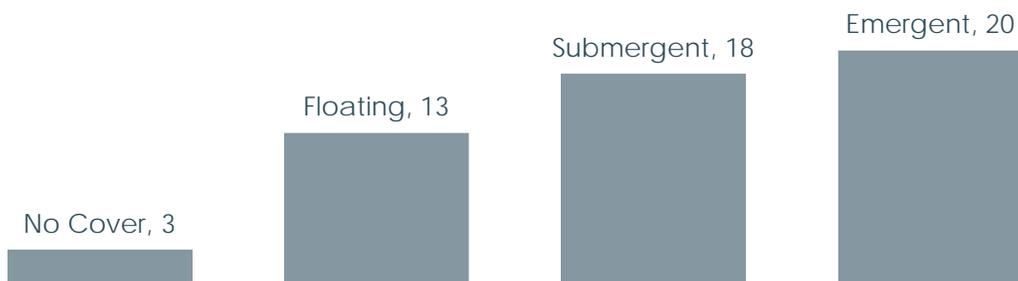
Figure 8 Aquatic Vegetation

On Burdock Lake, the number of properties with aquatic cover were observed and summarized. The presence and abundance of aquatic cover can vary throughout the year. Each assessed property could have one or more types of aquatic cover. Figure number 8 shows the number of properties on Burdock Lake had aquatic cover listed by type observed along their shoreline during the time of the assessments:

11% of properties on Burdock Lake had no aquatic plants while 74% of properties had emergent vegetation which is an important source of habitat for fish, and other aquatic organisms. Submergent and floating vegetation was found less frequently on Burdock Lake but is still an important part of the aquatic ecosystem, giving habitat to birds, frogs, dragonflies, and other wildlife. Aquatic cover can create places for wildlife to lay their eggs, provide a perch for predators of fish and insects and offer cover for wildlife. Shoreline property owners that are removing aquatic vegetation from their shoreline properties may be indirectly increasing the presence of invasive aquatic species. Aquatic vegetation may be a problem if there is an overabundance of it due to high nutrient levels entering the lake through runoff. By controlling nutrients entering the lake through well vegetated buffers and other actions shoreline property owners can maintain a healthy balance of aquatic habitat, and space for recreational activities.

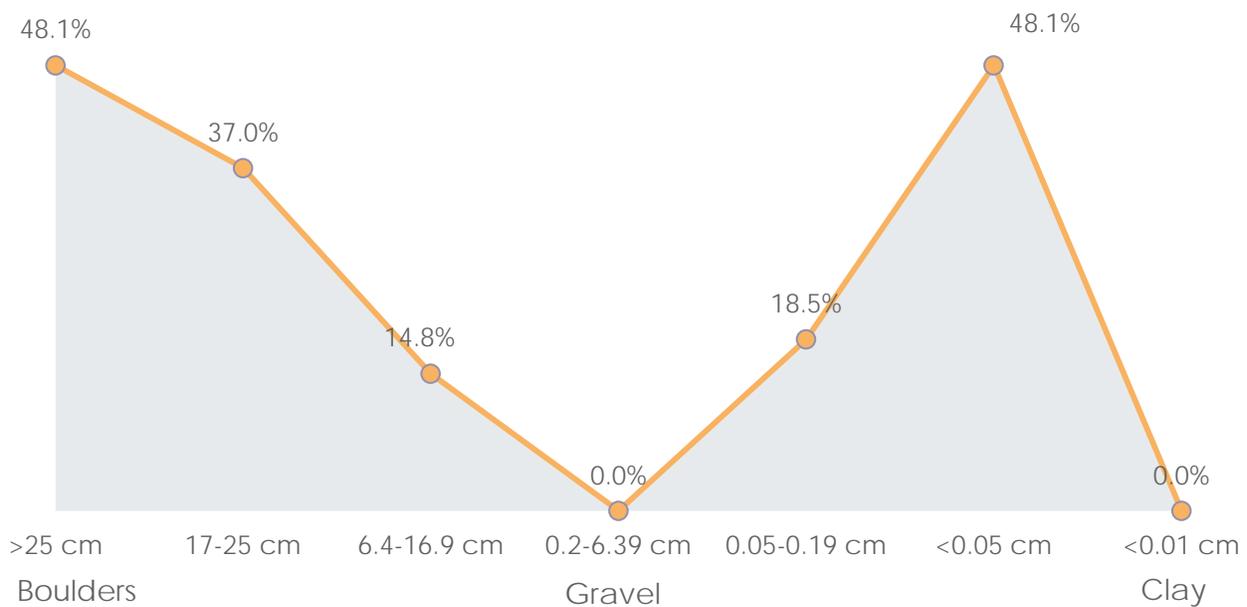
Figure 9 Sediment Distribution

On Burdock Lake, the aquatic substrate types were observed at each property. Figure 9 is the substrate size distribution on Burdock Lake. Aquatic substrate can be important habitat for fish and other aquatic wildlife and it is useful to document this feature to better inform future restoration projects on the lake. Burdock Lake was found to have a good variety of aquatic substrate throughout the lake for supporting aquatic biodiversity. Rubble and cobble provide great habitat for crayfish and spawning grounds for various species of fish while other environments provide excellent substrate for diverse aquatic vegetation.

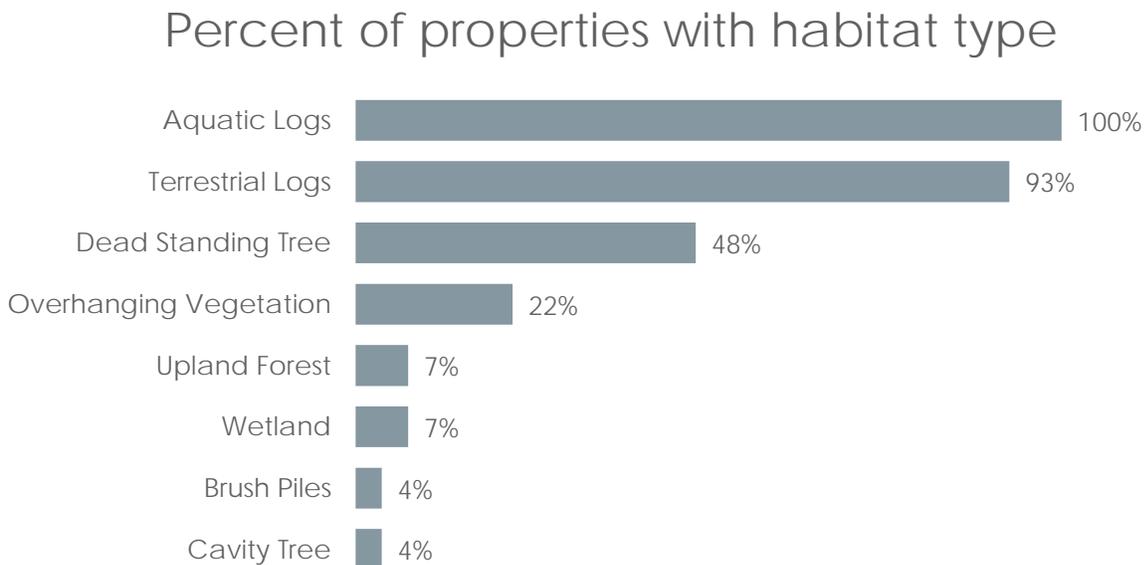
Figure 10 Habitat Present

Most common types of nearshore habitat on Burdock Lake were aquatic logs followed by terrestrial logs. All properties on Burdock Lake had some amount of habitat present. Wildlife provides us with many enjoyable and beneficial activities from bird watching and wildlife photography to pest control, seed dispersal, nutrient cycling and pollination, to name just a few. It is important for there to be a rich and diverse range of habitats along the lakeshore to ensure a healthy lake environment. Figure 10 summarizes the lake nearshore habitat.

It is important to leave large trees that are dead and dying in place, as they provide important habitat for a number of different species. In Ontario, more than 50 species of birds and mammals depend on cavity trees for nesting, rearing young, roosting, feeding, storing food, escaping predators, and hibernating. Fallen logs on land provide habitat for small mammals such as moles, woodpeckers, toads and insects. As the log decomposes, reptiles and amphibians lay their eggs in the moist wood. A decaying log is also great habitat for beetles, and ants that burrow under the bark and lay eggs. In the water, logs provide important fish habitat by providing

refuge for small fish, and spaces for ambush predators such as pike to conceal themselves. By leaving dead and decaying brush and logs in place, you are helping contribute to a healthy and vibrant species community.

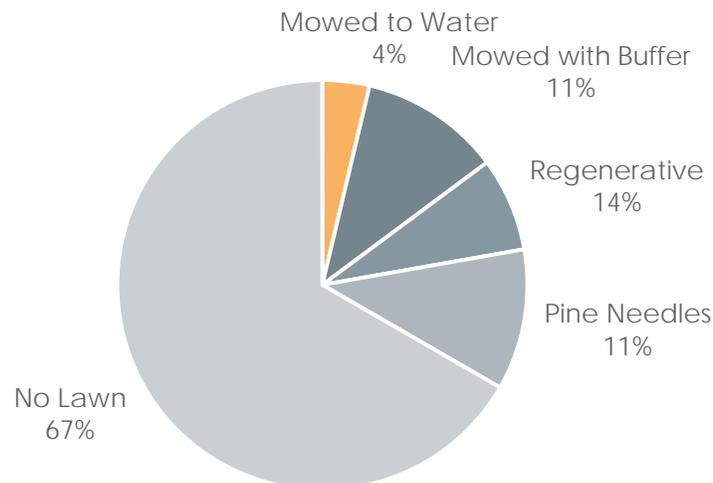
Figure 11 Lawn types

On Burdock Lake, the number of properties with lawns, either mowed or regenerative, was observed. 4% of properties with lawns were observed to have a mowed lawn to the water's edge. Natural ground cover and native vegetation, in comparison, slows runoff and allows filtration, removing many contaminants, pollutants, nutrients, sediment and other substances. These substances can be carried into the lake by runoff and can harm water quality and local ecological integrity. Lawn grasses also have short root systems and do not bind the soil well, which can lead to problems with erosion.

In areas close to shore, a lawn is generally not a good choice of ground cover as 55% of precipitation runs off mowed grass directly into the lake, instead of returning to groundwater. If shoreline property owners wish to mitigate this, they could consider allowing vegetation to regenerate on its own or by actively planting native trees, shrubs, grasses, or alternative ground cover. The roots of the vegetation will grip the soil, which can help prevent erosion. Allowing mowed lawns to regenerate to a more natural state promotes water conservation and protects surface and groundwater resources. Properties with regenerative lawns are encouraged to allow this natural process to continue and to enhance regeneration by planting native shrubs and trees.

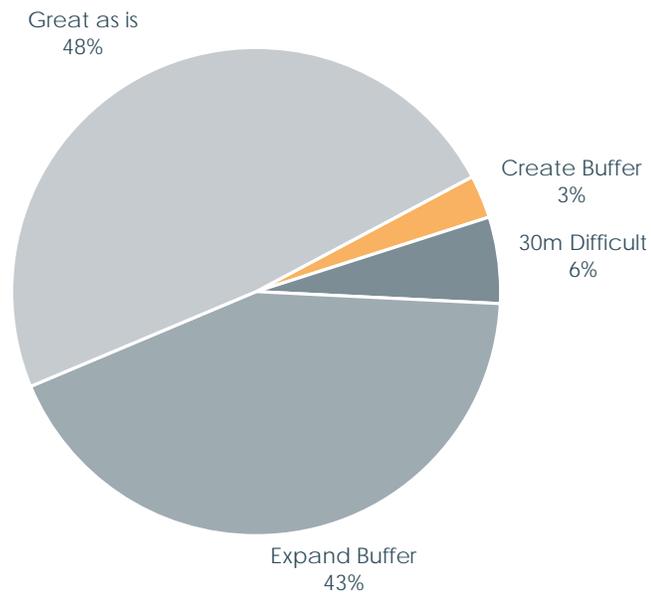
Figure 12 Buffer Recommendations

Arguably the most important element of a shoreline that property owners can easily influence is shoreline buffers. Buffers are an important element of natural shorelines that help filter nutrients, reduce erosion, and provide habitat. On Burdock Lake, 3% of properties have enough room between the main residence and the lake for the creation of a shoreline buffer to provide benefits to water quality and habitat. 48% of properties were noted to have great buffers as they are. In order to ensure the sustainability of a healthy lake environment it is important that natural buffers make up at least 75% of the lake shoreline, preferably as much as 80%.

They have an opportunity to plant a healthy buffer of native vegetation that could be 30 metres wide. When designing a planting plan, they can maintain room for access to the water (via raised staircases or covered, curved pathways). Lower growing vegetation can be chosen to maintain views to the water, and taller vegetation can be trimmed when it grows to substantial height.

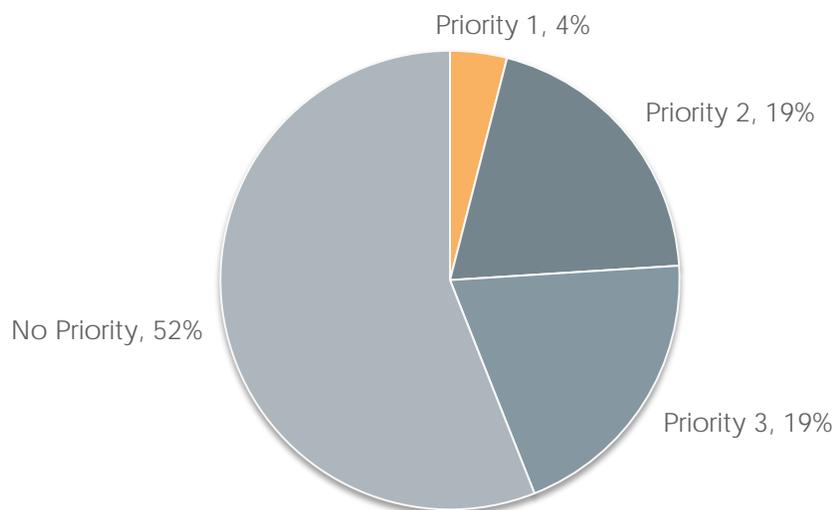
Figure 13 Naturalization Priorities

- Priority 1: The best candidates for naturalization efforts. These properties have more than 50% of their shoreline classified as ornamental. Additionally these properties have at least 30 metres of space between the water’s edge and their main building (house/cottage). These properties are recommended to either create a buffer or expand their current buffer.
 - These shoreline property owners are encouraged to naturalize their shorelines, because their efforts would have the greatest overall impact on the health of their shoreline and the lake.

- Priority 2: The second best candidates for naturalization efforts. These properties have more than 25% of their shoreline classified as ornamental. However, some of these properties have less than 30 metres of space between the water's edge and their main building (house/cottage), which could make planting more difficult or less substantial. These properties are also recommended to either create a buffer or expand their current buffer.

- Priority 3: These are the third best candidates for naturalization efforts. These properties are already mostly natural or regenerative, and less than 25% ornamental. However, some of these properties have less than 30 metres of space between the water's edge and their main building (house/cottage), which could make planting more difficult or less substantial.

There is some potential for shoreline naturalization on Burdock Lake as greater than 42% of the properties on the lake could potentially be a candidate for naturalization based on our assessment for shoreline naturalization projects. Buffer zones are the ribbon of life, providing over 90% of aquatic and terrestrial wildlife with essential habitat needed at some point throughout their various life stages, to mate, rear young, find food, or take shelter. Property owners who do not have 30 metres of space inland from the water's edge are encouraged to plant where they can. If support is needed in naturalization efforts, contact Coalition of Haliburton Property Owners' Associations at www.cohpoa.org or www.watersheds.ca
