Little Redstone Lake Shoreline Assessment Summary Report

June 2015

Submitted to the Little Redstone Lake Association by Watersheds Canada

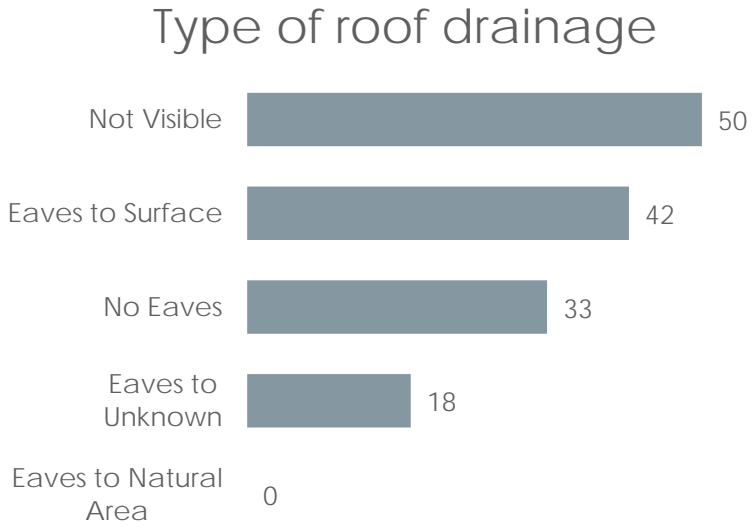
Figure 3 Roof Drainage types around lake

No properties on the lake were identified with having eaves that drain into a rain barrel or with eaves that drain into a natural area. These numbers may be higher, as there were nearly 50 properties where we were unable to identify from the water where the eaves drained to. Because rain barrels are bulky to transport to a cottage area, the lake association may look into ways to make them more available to shoreline property owners. Another option is to install French drains next to cottages to encourage water to percolate into the ground instead of running directly overland into the lake.

Naturalizing shorelines on properties with near-shore building setbacks would help reduce runoff from entering into Little Redstone Lake, which could help reduce potential problems such as algae blooms and loss of oxygen in the water. Property owners can also manage this problem by ensuring they have eaves troughs with downspouts directed at natural or stone catch basins or rain barrels, as well as ensuring they have a properly functioning septic to process wastewater before it enters the lake. As septic systems do very little to process nutrients, it is also important to use phosphate free products.

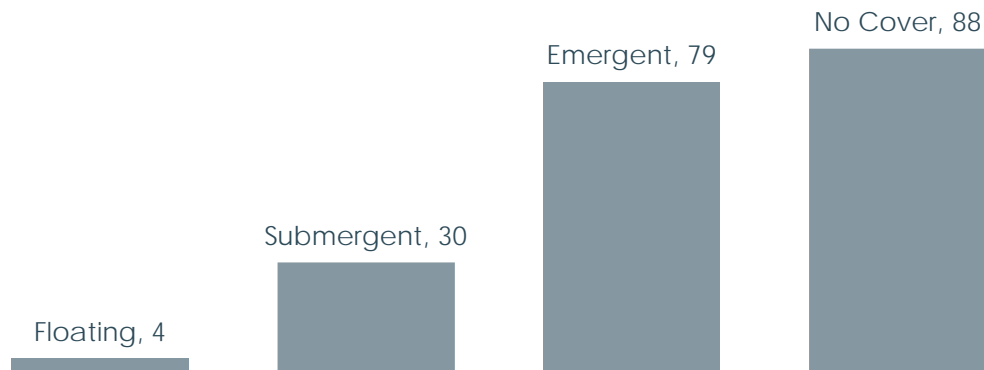
Figure 8 Aquatic Vegetation

On Little Redstone Lake, the number of properties with aquatic cover were observed and summarized. The presence and abundance of aquatic cover can vary throughout the year. Each assessed property could have one or more types of aquatic cover. Figure number 8 shows the number of properties on Little Redstone Lake had aquatic cover listed by type observed along their shoreline during the time of the assessments:

50% of properties on Little Redstone Lake had no aquatic plants while 45% of properties had emergent vegetation which is an important source of habitat for fish, and other aquatic organisms. Submergent and floating vegetation was found less frequently on Little Redstone Lake but is still an important part of the aquatic ecosystem, giving habitat to birds, frogs, dragonflies, and other wildlife. Aquatic cover can create places for wildlife to lay their eggs, provide a perch for predators of fish and insects and offer cover for wildlife. Shoreline property owners that are removing aquatic vegetation from their shoreline properties may be indirectly increasing the presence of invasive aquatic species. Aquatic vegetation may be a problem if there is an overabundance of it due to high nutrient levels entering the lake through runoff. By controlling nutrients entering the lake through well vegetated buffers and other actions shoreline property owners can maintain a healthy balance of aquatic habitat, and space for recreational activities.

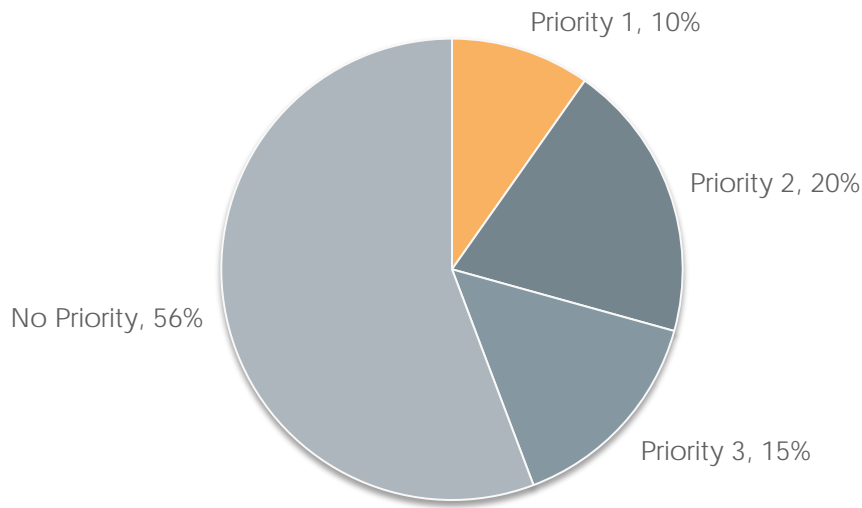
Figure 13 Naturalization Priorities

- Priority 1: The best candidates for naturalization efforts. These properties have more than 50% of their shoreline classified as ornamental. Additionally these properties have at least 30 metres of space between the water's edge and their main building (house/cottage). These properties are recommended to either create a buffer or expand their current buffer.

- Priority 2: The second best candidates for naturalization efforts. These properties have more than 25% of their shoreline classified as ornamental. However, some of these properties have less than 30 metres of space between the water's edge and their main building (house/cottage), which could make planting more difficult or less substantial. These properties are also recommended to either create a buffer or expand their current buffer.

- Priority 3: These are the third best candidates for naturalization efforts. These properties are already mostly natural or regenerative, and less than 25% ornamental. However, some of these properties have less than 30 metres of space between the water's edge and their main building (house/cottage), which could make planting more difficult or less substantial.

There is potential for shoreline naturalization on Little Redstone Lake as 45% of the properties on the lake could potentially be a candidate for naturalization based on our assessment for shoreline naturalization projects. Buffer zones are the ribbon of life, providing over 90% of aquatic and terrestrial wildlife with essential habitat needed at some point throughout their various life stages, to mate, rear young, find food, or take shelter. Property owners who do not have 30 metres of space inland from the water’s edge are encouraged to plant where they can. If support is needed in naturalization efforts, contact Coalition of Haliburton Property Owners’ Associations at www.cohpoa.org or www.watersheds.ca
