Pelaw Lake Shoreline Assessment Summary Report

June 2015

Submitted to the Pelaw Lake Association by Watersheds Canada

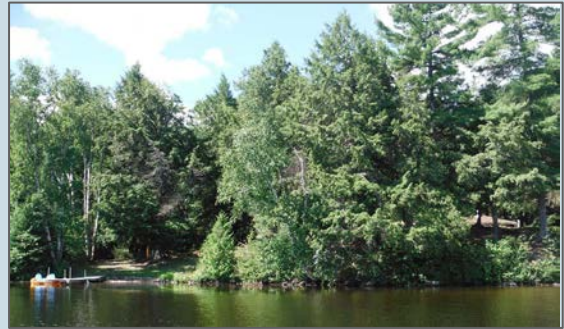
Natural – A healthy buffer of vegetation and/or a natural shoreline of sand or exposed rock that is undisturbed and undeveloped.

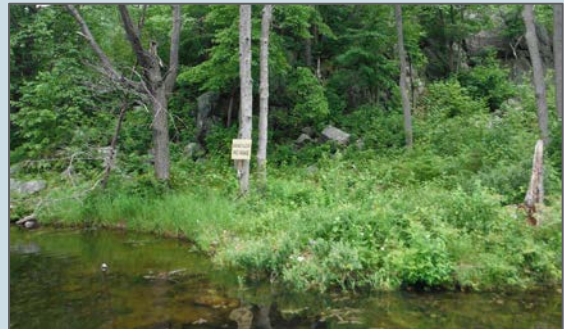
Regenerative – Natural vegetation has been removed in the past, but is in the process of growing back towards a natural state.

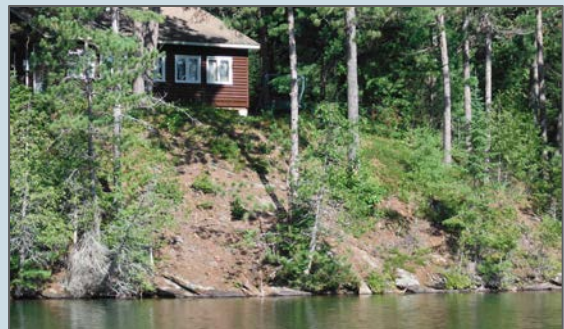
Degraded – Natural vegetation has been lost; soil erosion, undercutting of the bank, and/or exposed roots of shrubs and trees are significant.

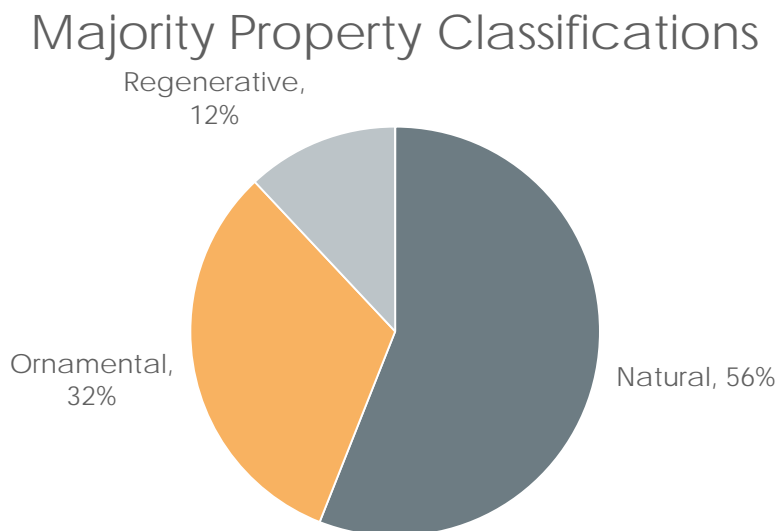
Figure 1 Property Classifications

On Pelaw Lake, the majority of the shoreline (56%) is classified as natural, followed by 32% being ornamental and 12% being regenerative. It is recommended that shoreline property owners engage in naturalization projects to further decrease the ornamental percentage and increase the regenerative and natural percentages. Pelaw Lake is above the recommended limit of 25% developed shoreline.

This presents an opportunity for residents of Pelaw Lake to enhance the overall quality of the lake by maintaining, protecting and enhancing natural shorelines. To restore shorelines to more natural states, property owners are encouraged to take action. Regenerative properties should be encouraged to maintain their properties in a natural state.

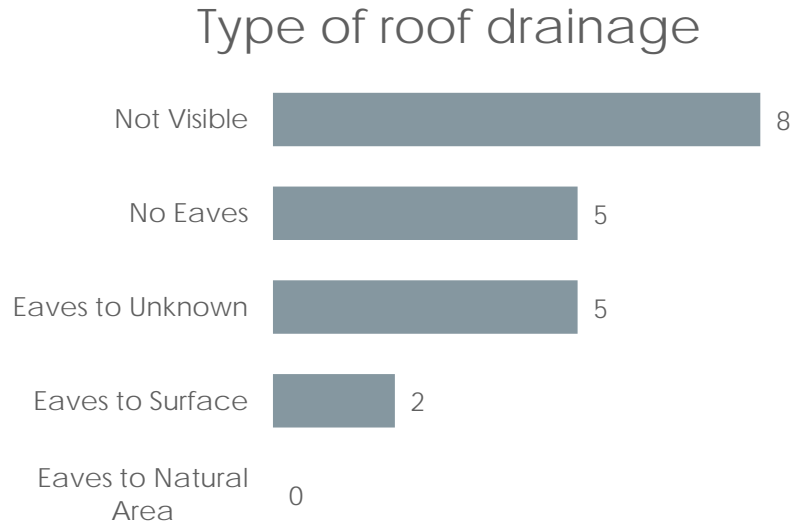
Figure 3 Roof Drainage types around lake

No properties on the lake were identified with having eaves that drain into a rain barrel or with eaves that drain into a natural area. These numbers may be higher, as there were nearly 8 properties where we were unable to identify from the water where the eaves drained to. Because rain barrels are bulky to transport to a cottage area, the lake association may look into ways to make them more available to shoreline property owners. Another option is to install French drains next to cottages to encourage water to percolate into the ground instead of running directly overland into the lake.

Naturalizing shorelines on properties with near-shore building setbacks would help reduce runoff from entering into Pelaw Lake, which could help reduce potential problems such as algae blooms and loss of oxygen in the water. Property owners can also manage this problem by ensuring they have eaves troughs with downspouts directed at natural or stone catch basins or rain barrels, as well as ensuring they have a properly functioning septic to process wastewater before it enters the lake. As septic systems do very little to process nutrients, it is also important to use phosphate free products.

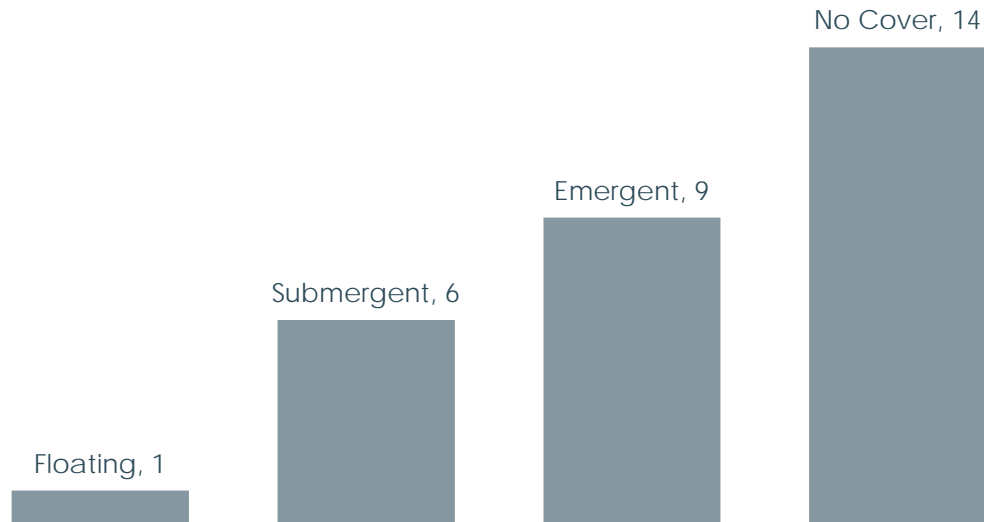
Figure 8 Aquatic Vegetation

On Pelaw Lake, the number of properties with aquatic cover were observed and summarized. The presence and abundance of aquatic cover can vary throughout the year. Each assessed property could have one or more types of aquatic cover. Figure number 8 shows the number of properties on Pelaw Lake had aquatic cover listed by type observed along their shoreline during the time of the assessments:

56% of properties on Pelaw Lake had no aquatic plants while 36% of properties had emergent vegetation which is an important source of habitat for fish, and other aquatic organisms. Submergent and floating vegetation was found less frequently on Pelaw Lake but is still an important part of the aquatic ecosystem, giving habitat to birds, frogs, dragonflies, and other wildlife. Aquatic cover can create places for wildlife to lay their eggs, provide a perch for predators of fish and insects and offer cover for wildlife. Shoreline property owners that are removing aquatic vegetation from their shoreline properties may be indirectly increasing the presence of invasive aquatic species. Aquatic vegetation may be a problem if there is an overabundance of it due to high nutrient levels entering the lake through runoff. By controlling nutrients entering the lake through well vegetated buffers and other actions shoreline property owners can maintain a healthy balance of aquatic habitat, and space for recreational activities.

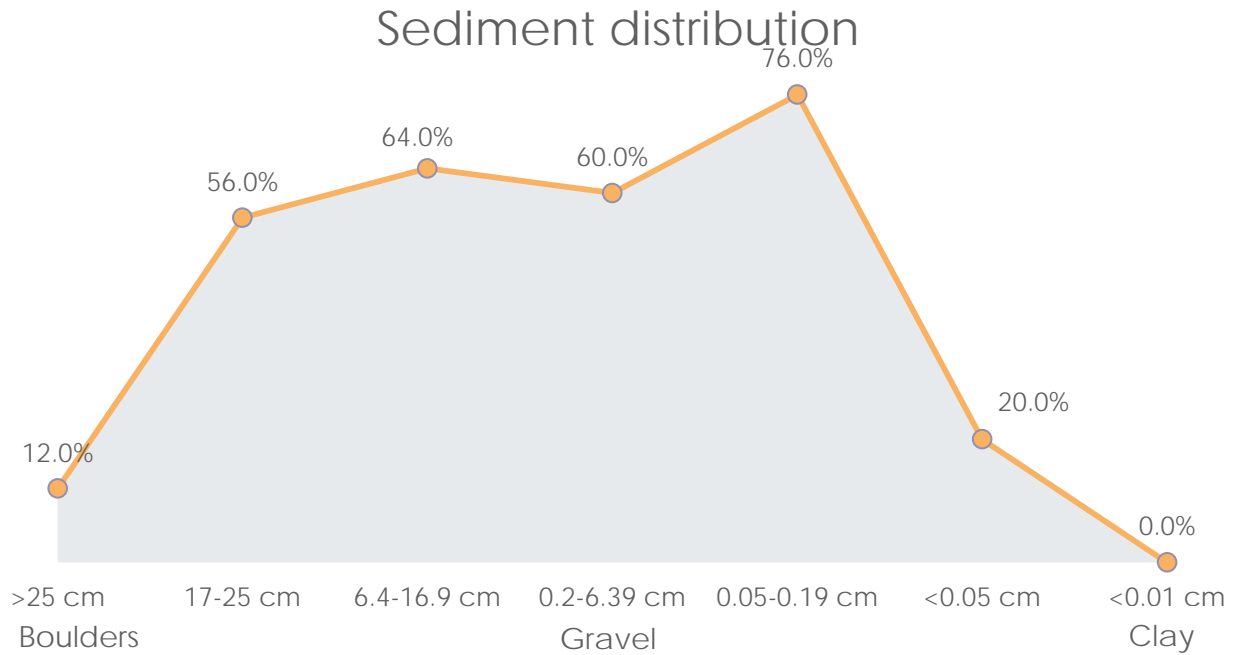
Figure 9 Sediment Distribution

On Pelaw Lake, the aquatic substrate types were observed at each property. Figure 9 is the substrate size distribution on Pelaw Lake. Aquatic substrate can be important habitat for fish and other aquatic wildlife and it is useful to document this feature to better inform future restoration projects on the lake. Pelaw Lake was found to have a good variety of aquatic substrate throughout the lake for supporting aquatic biodiversity. Rubble and cobble provide great habitat for crayfish and spawning grounds for various species of fish while other environments provide excellent substrate for diverse aquatic vegetation.

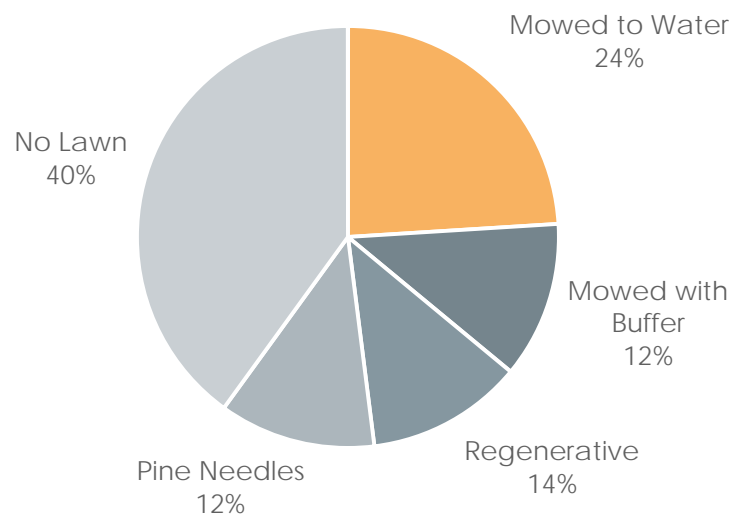
Figure 11 Lawn types

On Pelaw Lake, the number of properties with lawns, either mowed or regenerative, was observed. 24% of properties with lawns were observed to have a mowed lawn to the water's edge. Natural ground cover and native vegetation, in comparison, slows runoff and allows filtration, removing many contaminants, pollutants,

In areas close to shore, a lawn is generally not a good choice of ground cover as 55% of precipitation runs off mowed grass directly into the lake, instead of returning to groundwater. If shoreline property owners wish to mitigate this, they could consider allowing vegetation to regenerate on its own or by actively planting native trees, shrubs, grasses, or alternative ground cover. The roots of the vegetation will grip the soil, which can help prevent erosion. Allowing mowed lawns to regenerate to a more natural state promotes water conservation and protects surface and groundwater resources. Properties with regenerative lawns are encouraged to allow this natural process to continue and to enhance regeneration by planting native shrubs and trees.

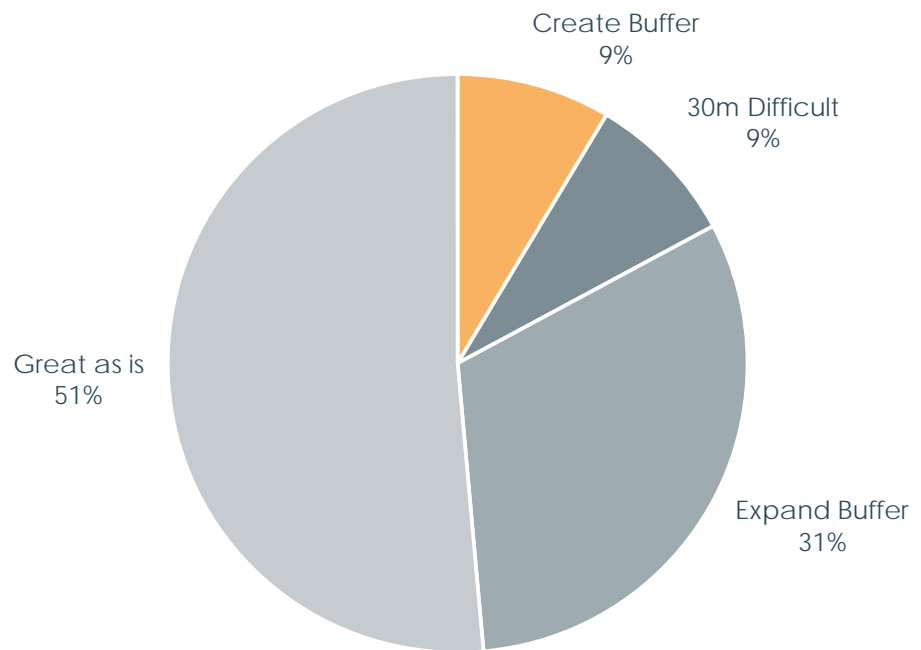
Figure 12 Buffer Recommendations

Arguably the most important element of a shoreline that property owners can easily influence is shoreline buffers. Buffers are an important element of natural shorelines that help filter nutrients, reduce erosion, and provide habitat. On Pelaw Lake, 9% of properties have enough room between the main residence and the lake for the creation of a shoreline buffer to provide benefits to water quality and habitat. 51% of properties were noted to have great buffers as they are. In order to ensure the sustainability of a healthy lake environment it is important that natural buffers make up at least 75% of the lake shoreline, preferably as much as 80%.

There are a number of options shoreline property owners have to improve or increase the size of their buffer. Watersheds Canada and the Canadian Wildlife Federation is offering shoreline naturalizations funded through the Department of Fisheries and Oceans Canada. The data collected previous in this report was used to calculate shoreline naturalization priorities. The categories are as follows:
